# The Crash of One-Two-GO Airlines Flight 269

The Etiology of a Preventable Accident

Dr. Bob Baron, Ph.D

The Aviation Consulting Group

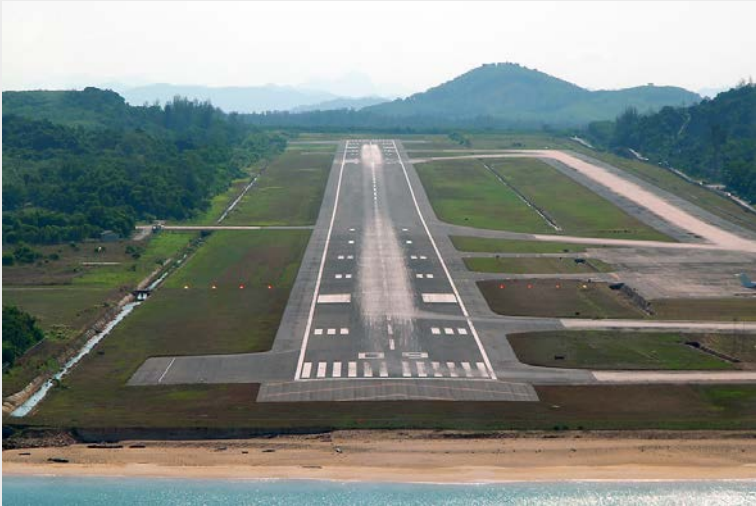
Phuket Intl. Airport (HKT)  
Photo credit: Jakkrit Prasertwit

- HKT is categorized in Aerodrome Reference Code 4E.
- However, its runway strips are 75 meters in width on each side of the center line, which did not comply with the SARP of Annex 14: Precision Approach Runway
  - Annex 14 specifies that the width of runway strips shall extend laterally to a distance of at least 150 meters on each side.
- HKT does not meet this criteria due to the fact that the airport has physical limitation surfaces: the embankment on the side of its runway.
- This limitation is announced in the AIP Thailand.

- Expedite the improvement of runway strip to meet the standard prescribed in Annex 14 of ICAO or revise the category of instrument approach procedure to suit the current runway strip. The Company shall also establish an SMS in order to identify and mitigate the risk.
